Instrument Retrieval from Central Incisor – A Case Report

Instrument separation is a very common mishap in routine endodontic practice. Although fractured fragment does not affect the prognosis of the case, it may affect the subsequent steps in endodontic therapy, such as chemomechanical preparation, obturating root canals. In case of separated instrument, attempts should be made to retrieve the instrument where possible or one should try to bypass the fragment. This case report describes the retrieval of a separated instrument from central incisor of 18-year-old boy.

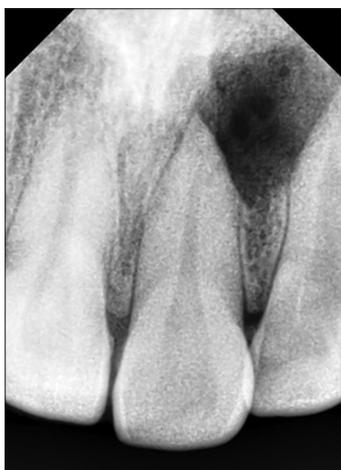
Figure 1: Intra-oral periapical radiograph

An 18-year-old male patient was referred to our clinic with pain and swelling with maxillary left central incisor. Mild swelling and pus discharge were seen with respect to 21 and 22. The patient was referred for the management of separated endodontic file. The referring dentist gave a history of separation of Proglider file in the central incisor 2 days ago. He also sent the pre-operative intraoral periapical (IOPA) [Figure 1].

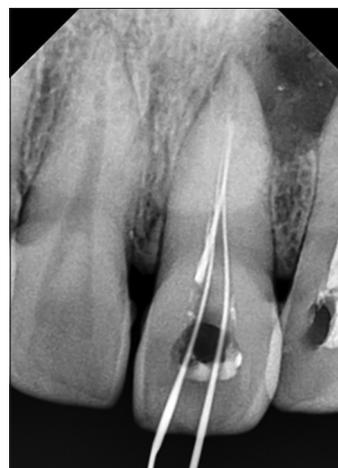
Figure 3: Engaging the fractured fragment in two files

After biomechanical preparation up to F2, the separated fragment became little loose in the canal. Ultrasonic tips (Cric Dental) were used to loosen it further. Two K-files No. 15 and No. 20 were inserted simultaneously to engage the fractured fragment. Once the fragment was engaged, the files were used to retrieve the fragment [Figure 3]. IOPA was taken to confirm the complete retrieval [Figures 4 and 5].

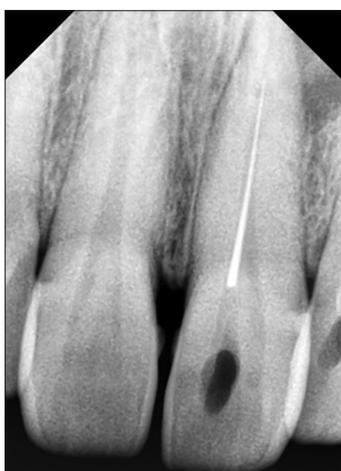
Figure 2: Intra-oral periapical radiograph to confirm the separated instrument in canal

IOPA radiographs were taken to confirm the fractured fragment in the canal [Figure 2]. Periapical radiolucency

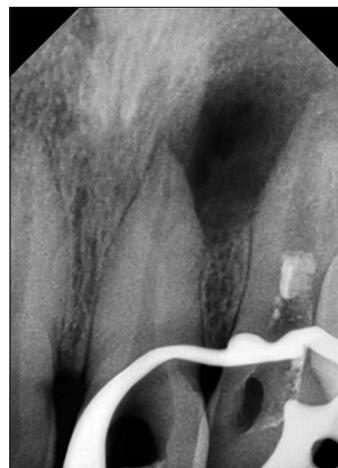
Figure 4: Intra-oral periapical radiograph to confirm retrieval of file

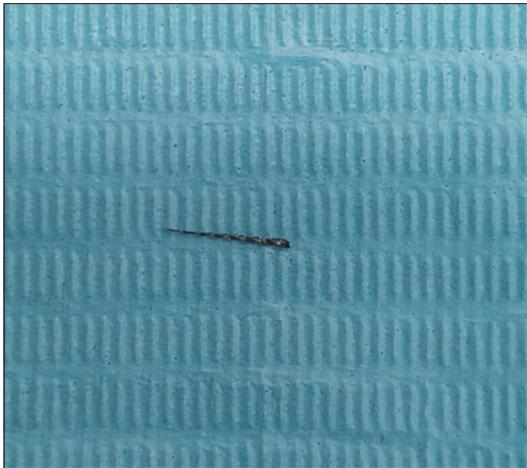
Figure 5: Retrieved fragment

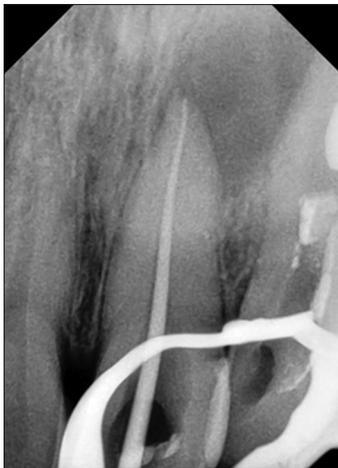
Figure 6: Master cone selection

After the retrieval, through irrigation with 3% sodium hypochlorite was done. Master cone selection was done [Figure 6]. Canals were dried with paper points and obturated using cold lateral condensation technique [Figure 7]. The patient was then kept under recall.

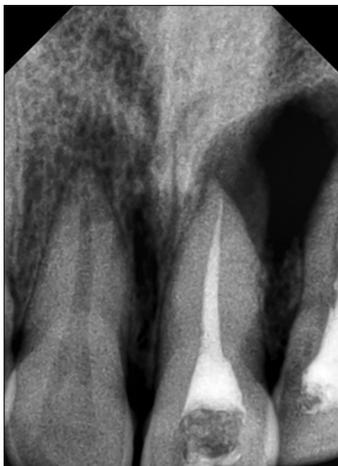
Figure 7: Post obturation intra-oral periapical radiograph
