# Evaluation of the Mode of Failure of Glass Fiber Posts: An *In Vitro* Study

**Purpose:** The purpose of the present study is to evaluate the mode of failure of glass fiber post.

**Materials and Methods:** 20 extracted single-rooted teeth were endodontically treated and restored with glass fiber posts. They were then loaded using Universal testing Machine until catastrophic failure occurred. Then, the mode of failure of each sample was determined and categorized as (a) root fracture, (b) core fracture, (c) post fracture, and (d) post debonding.

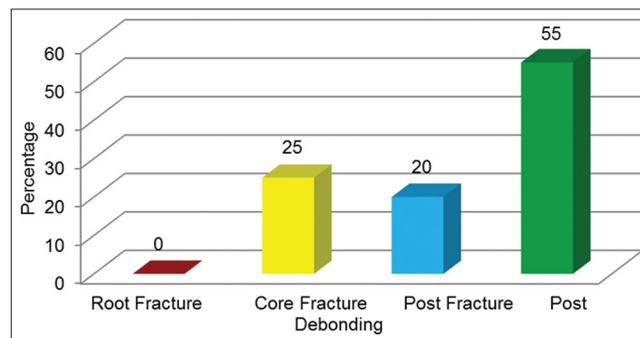
**Graph 1: Mode of failure of restoration in glass fiber post system**

**Results:** 11 samples showed post debonding as a mode of failure. In 05 samples, there was core fracture and post fractured in the remaining 04 samples.

Glass fiber post	Type of failure	No. of samples
Group II	Root fracture	00
	Core fracture	05
	Post fracture	04
	Post debonding	11

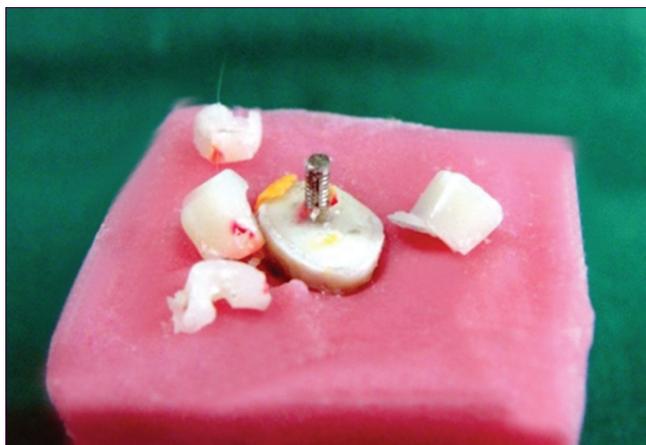
Figure 1: The core fracture in the sample.

- Step 9: Identification of mode of failure.
- All samples were subjected to radiographic evaluation.
  - The mode of failure was recorded as:
    - Root fracture
    - Core fracture (Figure 1)
    - Post fracture (Figure 2)
    - Post debonding (Figure 3).

When considering fiber post and composite core, it was suggested that resin fiber posts are industrially cured, with a high level of polymerization and concomitant relatively small quantities of free resin available to interact with the reactive chemical constituents present in resin lutes or composite resin cores.

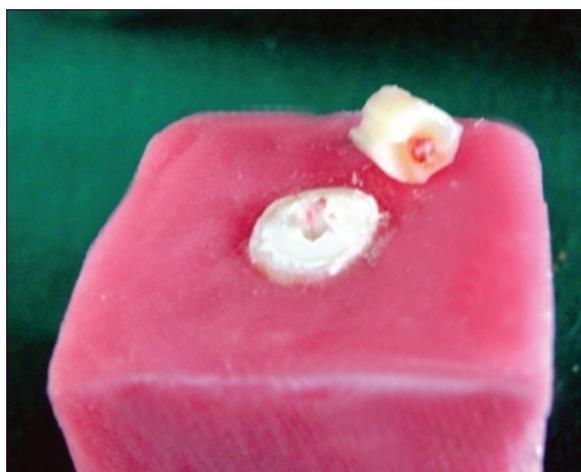
Figure 2: Post debonding in the sample

Most of the failure associated with the fiber posts are due to the debonding. The debonding between post-cement interface rather than cement-dentin or intracement fracture (cohesive failure of cement). This debonding is often attributed to various causes like Most of the fiber post are made of highly cross-linked epoxy resin which makes it difficult to bond with methacrylate based resin cement.<sup>22</sup> Other reasons might be change in physical properties such as flexural strength and modulus of elasticity due to water sorption during prolonged storage (leading to expansion), changes in temperature (difference in coefficient of thermal expansion of fiber post, dentin, and core material), and dynamic functional loading.<sup>12,22-25</sup>

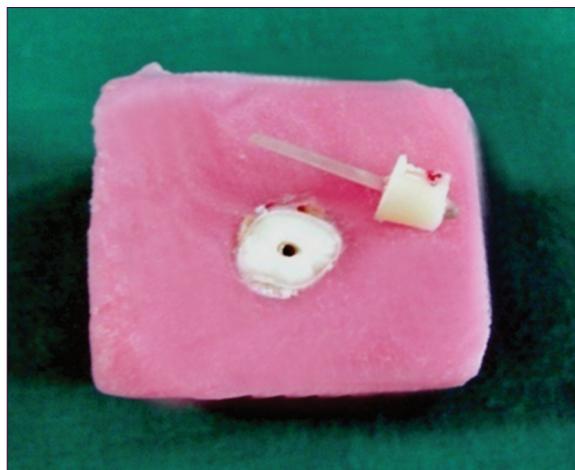
Figure 3: The post debonding in the sample
