# Salvaging an Implant with Abutment Screw Fracture by a Custom Titanium Post and Core Supported Prosthesis - A Novel Technique

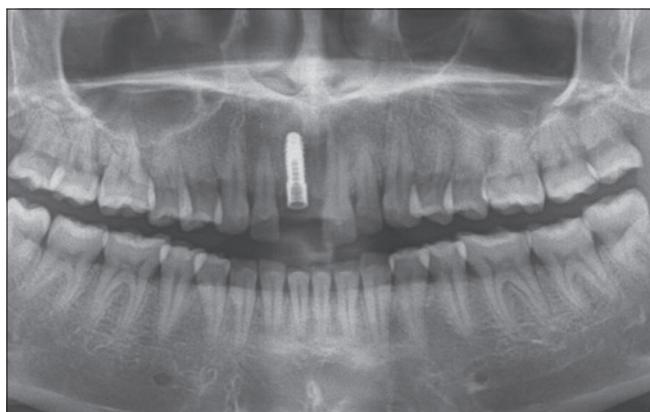
**Figure 1:** Oral pantamogram of the patient immediately after the placement of implant

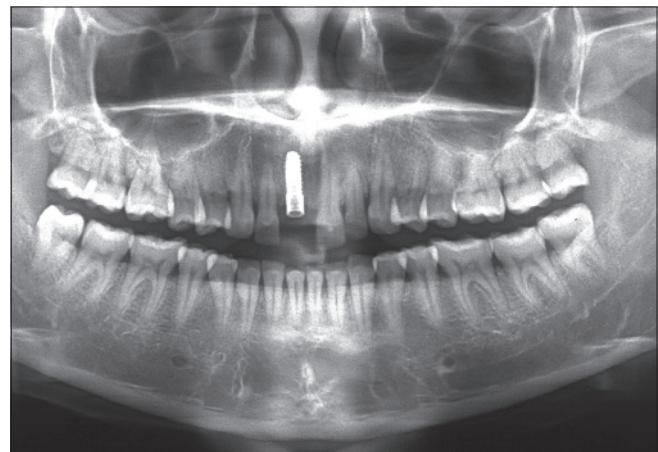
**Figure 3:** Oral pantamogram of the patient showing abutment screw fracture below the head of implant

A twenty four year old female patient reported to the Department of Prosthodontics, Govt. Dental College, Thiruvananthapuram with a chief complaint of dislodged crown in relation to an implant placed 5 years back in the upper anterior region (Figure 1). She noticed the mobility of the crown about three months back which gradually increased. But due to her personal commitments was unable to seek treatment on time. This was a typical case of screw loosening which eventually led to screw fracture (Figure 2). Intra oral examination revealed an implant supported crown at 11 with abutment screw fracture below the level of implant head. Radiographs revealed an osseointegrated endosseous screw form implant with the fractured screw fragment locked in the screw hole at around 5mm below the head of implant making its retrieval challenging (Figure 3). The other half of the fractured screw along with the abutment was in the dislodged crown. The fractured screw was visualized under magnification ( $\times 2.5$ ). Internal threads of the screw hole appeared damaged under magnification (Figure 4). A fine ultrasonic endodontic tip was placed on the screw and vibrated at a low setting. There was

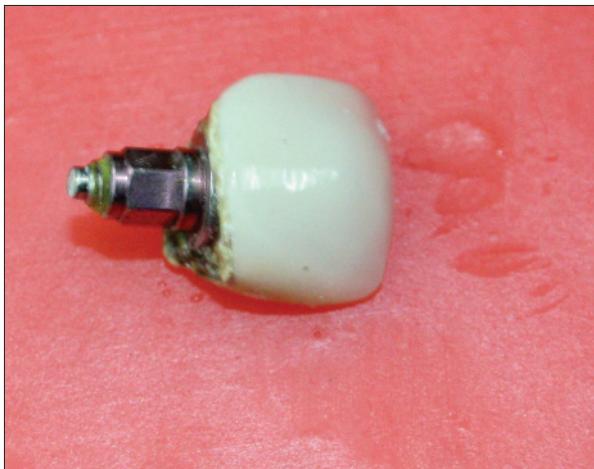
**Figure 2:** Crown with the fractured abutment screw

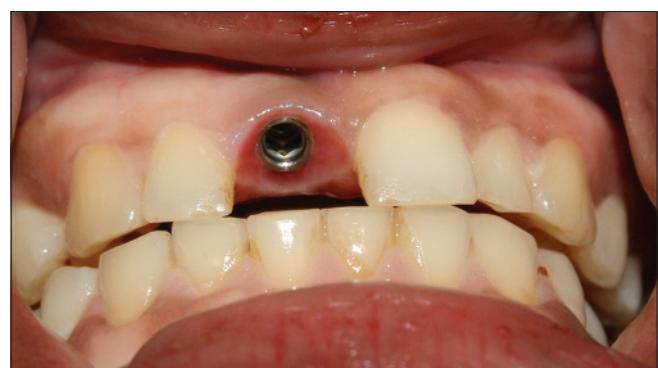
**Figure 4:** Damaged internal threads of the implant

no movement of the screw. Other methods of retrieval of screw fragment<sup>10</sup> was employed which also failed. This can be attributed to the damaged internal threads of the screw hole. The patient was unwilling to undergo extensive procedure of implant removal and placement of new implant and thus it was decided to use the screw hole as a channel for custom fabricated titanium post and core. The internal threads of the implant was eliminated (Figure 5) using a tungsten carbide bur (170 L) in a high speed air rotor handpiece under copious saline irrigation (Figure 6). Coronal fragment of the fractured segment was removed using a 8mm round ended tapered diamond and carbide bur to provide space for sufficient length of post which could resist the torsional forces. An acrylic resin pattern for the post was fabricated directly in the post space with an autopolymerizing acrylic resin and plastic pin using a brush-on technique (Figure 7). Care was taken to prevent locking of the pattern in the screw hole by removing it before it was completely polymerized. After the polymerization is complete, the pattern is replaced and the core portion is fabricated with resin, trimmed, finished and polished to appropriate length and shape (Figure 8). The pattern was sent to the lab for fabrication of titanium cast post and core (Figure 9). The titanium dowel core was tried in the screw hole (Figure 10). It was cemented into the implant using zinc phosphate cement (Phosphate

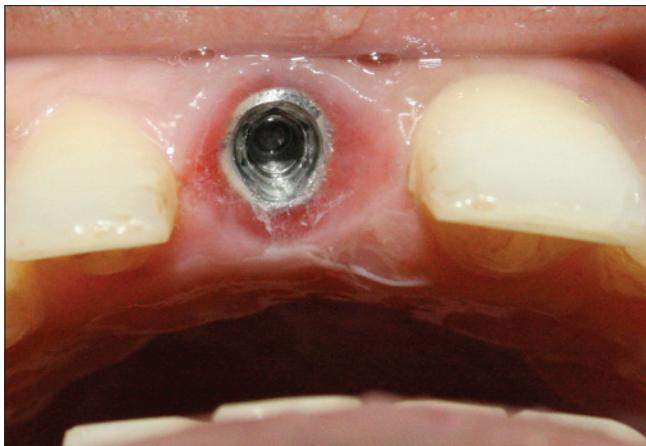
Figure 5: Prepared post space in implant by removing the internal threads

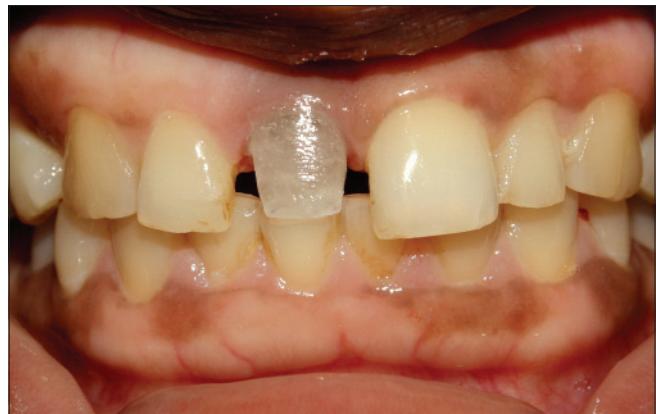
Figure 8: Trial of the pattern

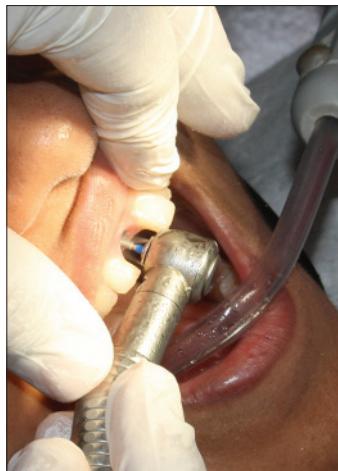
Figure 6: Post space preparation by removing the internal threads using tungsten carbide bur in a high speed air rotor under copious irrigation

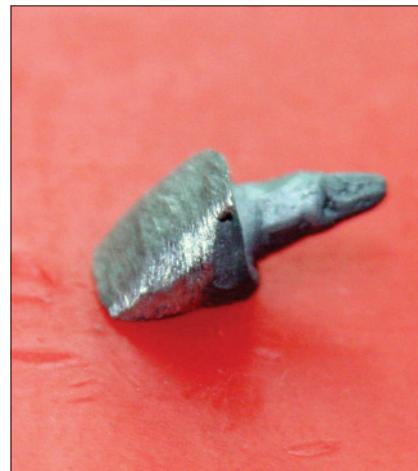
Figure 9: Custom post and core

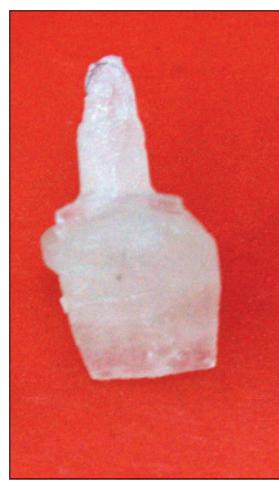
Figure 7: Pattern for the custom post and core made using clear autopolymerizing acrylic resin

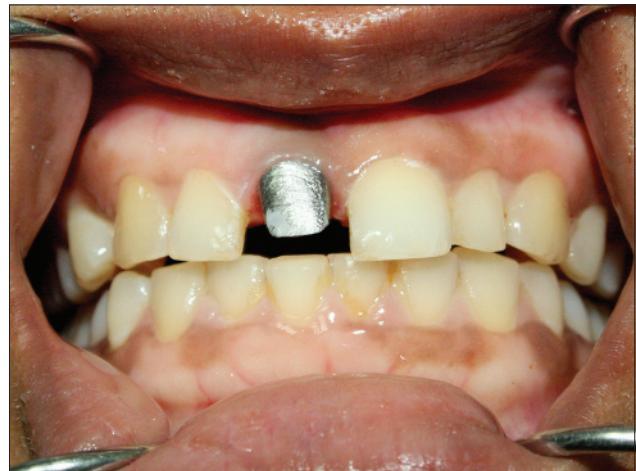
Figure 10: Custom post and core cemented to the implant using zinc phosphate cement

cement, Heraeus Kulzer, Germany). After cementation of the post and core, metal ceramic crown was fabricated following

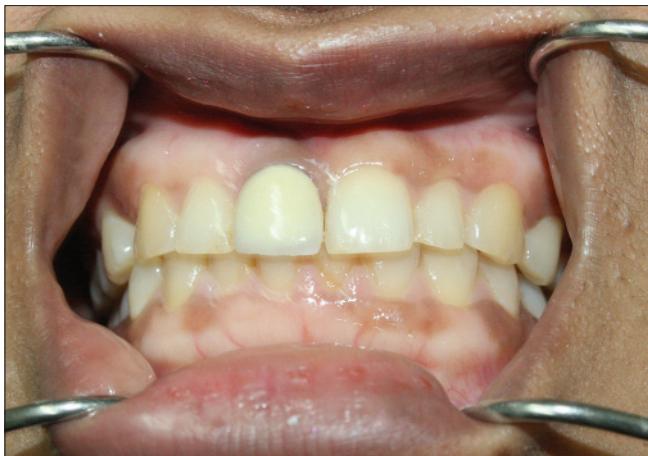
Figure 11: Metal ceramic crown cemented over the cast core.  
Post operative intra oral view

conventional prosthodontic procedure. The crown was cemented after eliminating the interferences in all protrusive and lateral excursive movements (Figure 11). The patient was followed up after six months with no signs of complications or failure of prosthesis (Figure 12).
