# A Case Report on Migrated Kirschner Wires to Posterior Pharyngeal Wall

**Keywords:** Ante grade migration, Early retrieval, Kirschner wires

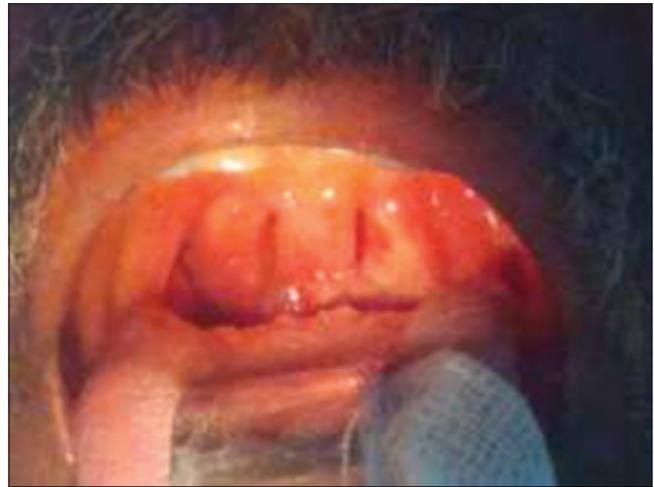
Figure 3: Tip of metal object jetting at the inferior oropharynx at the posterior pharyngeal wall and also noted pus around the foreign body

ENT opinion was obtained. Endoscopy examination showed tip of the metal object jetting at the inferior

oropharynx at the posterior pharyngeal wall and also noted pus around the foreign body (Figure 3).

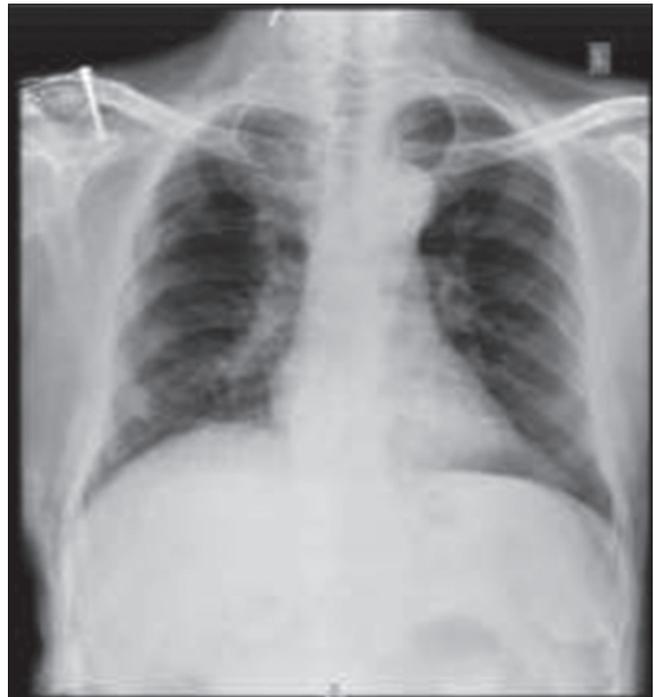
Figure 4: Tension band wiring with screw fixation in right shoulder and tip of a metal object at the neck level

His routine chest X-ray showed tension band wiring with screw fixation in right shoulder and tip of the metal object at the neck level (Figure 4). We further evaluated with C spine X-ray which showed a metal object, a K-wire probably at the surface of posterior pharyngeal wall (Figures 5 and 6).

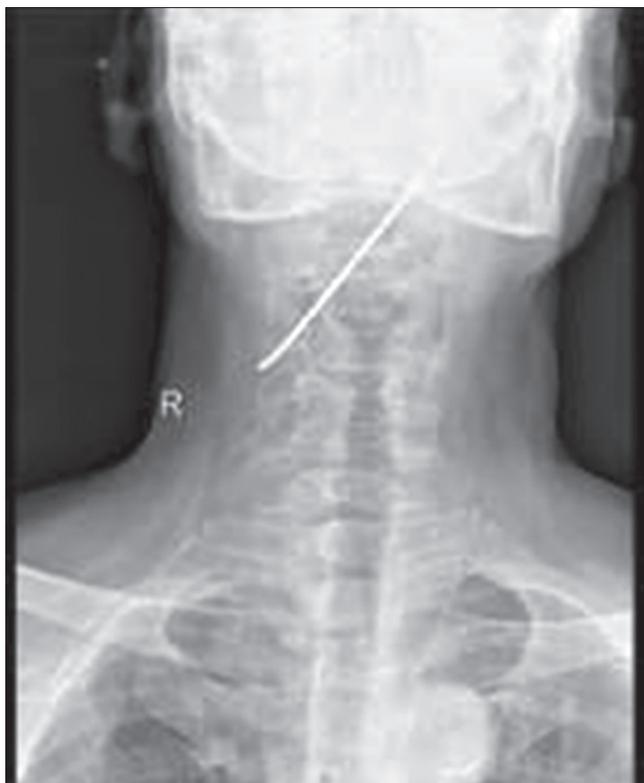
Figure 5: X-ray Ap view showing metal object in the neck region

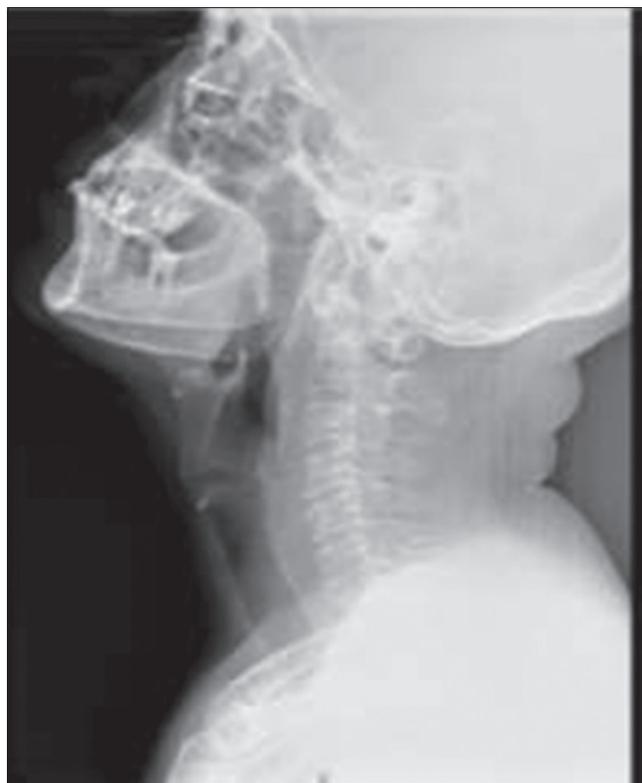
Figure 7: No evidence of foreign body-foreign body was self-expelled by the patient himself while violent coughing episode

by the patient himself while violent coughing episode. C spine X-ray taken after self-expellation of the metal object showed no evidence of foreign body (Figure 7). On routine follow-up at 6 months, patient was comfortable without any residual throat discomfort.

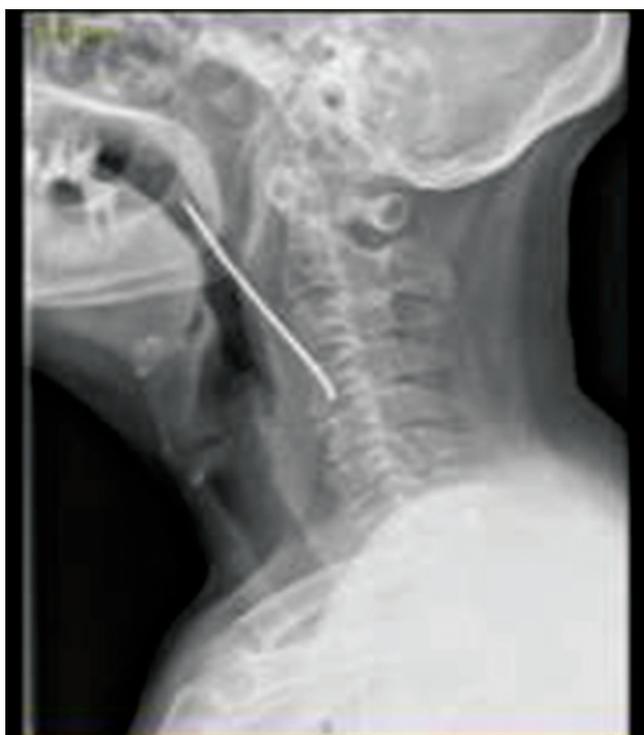
Figure 6: X-ray lat view showing metal object, a Kirschner wire probably at the surface of posterior pharyngeal wall
