Maxillary Central Incisor with two Root Canals and two Separated Roots: A Case Report

Maxillary central incisors have been reported as presenting with only 1 root canal and a single root in 100% of cases. Variations in the number of roots or canals in the upper central incisors are rare. Therefore, to achieve a technically satisfactory endodontic outcome, the clinician must have adequate knowledge of the internal canal morphology and be aware of the possible variations. The purpose of this study was to report a clinical case with a varying number of roots in a right maxillary central incisor. After the appropriate cleaning and shaping of the missed root canal, it was filled using the Tagger's technique. Cone beam computed tomography follow up showed complete healing of the lesion after 36 months.

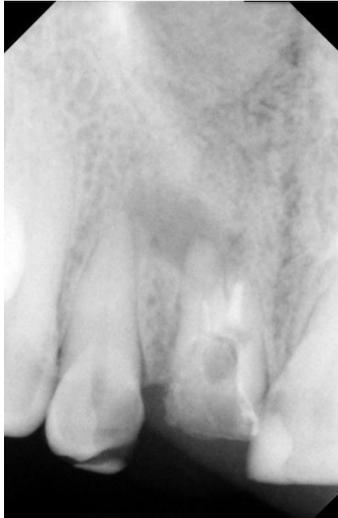
Figure No. 1

Radiographic examination (fig. 1) revealed that the tooth had 2 separated roots. The buccal root exhibited radiopaque material, and the palatal root showed a narrow canal and an apical radiolucent area.

After local anesthetization with 3% prilocaine and 0.03 IU/mL felipressine (DFL, Rio de Janeiro, Brasil), the tooth was isolated with a rubber dam, all the provisional cement was removed and the pulp chamber was irrigated with 2.5% sodium hypochlorite (Biodinâmica, São Paulo, Brazil). Using an 8× magnification on a dental operating microscope (DFVasconcellos, Rio de Janeiro, Brazil), the gutapercha present in the buccal canal was assessed. The entrance of the palatal root was obliterated. Using TRA 01 and TRA 24D ultrasonic tips (Dental Trinks, São Paulo, Brazil) and with the illumination and magnification provided by the microscope, the palatal root was located and negotiated. The working length was established with an apex locator (Sybron Endo, California, USA) and a radiograph was taken to confirm the patency of the canal. No treatment was performed on the buccal canal.

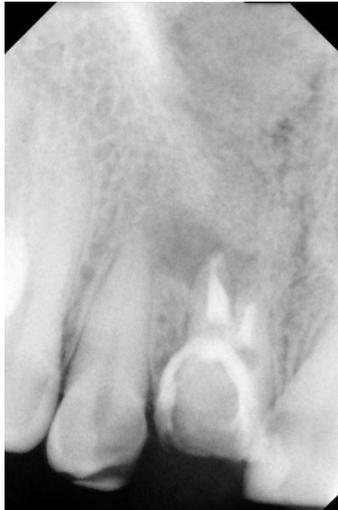
Figure No. 2

Final radiographs were taken from the orto, mesial, and distal aspects. A prosthesis was cemented and the patient was referred for general dentistry. Due to the initial attempt at canal location, a deviation was observed in the palatal root. (fig. 2)

At the following appointment, the patient was asymptomatic with the provisional crown not showing any clinical sign of leakage. After anesthesia and placement of the rubber dam, the root canal was again accessed. The calcium hydroxide dressing was removed, the canal was irrigated with sodium hypochlorite then EDTA, and passive ultrasonic irrigation was performed using the same protocol as for the first visit, and finally the root canal was dried with paper points. Filling was performed with standard #60 gutta percha points and accessory M, FM, and F (Dentsply, Petropolis, Brasil). Endofill (Dentsply, Petropolis, Brasil) cement and Tagger's technique were used to complete the root canal filling.

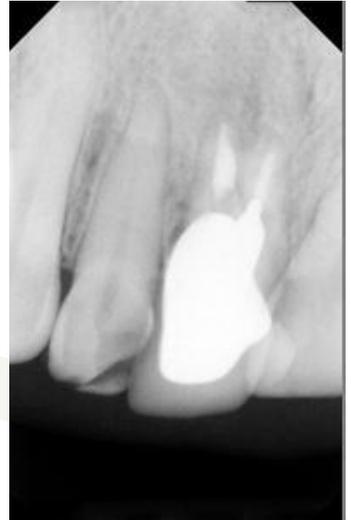
Figure No. 3

Thirty-six months after treatment, the patient was asymptomatic; the probing test was normal and a permanent crown was complete. Radiographic examination (fig. 3) revealed that the radiolucent area had become normal with characteristics of a healing area. With the aid of cone beam computed tomography the independent roots could be visualized (fig 4,5). The original lesion was completely healed, and there was no perforation at the palatal root.
